**AIRPARK DRIVE GROUND STORAGE RESERVOIR  
INSPECTION REPORT**

## COATING EVALUATION REPORT

### AIRPARK GROUND STORAGE RESERVOIR (300,000-Gallons Capacity)

**QCS PROJECT NO. CC 007-QCS-009-001**

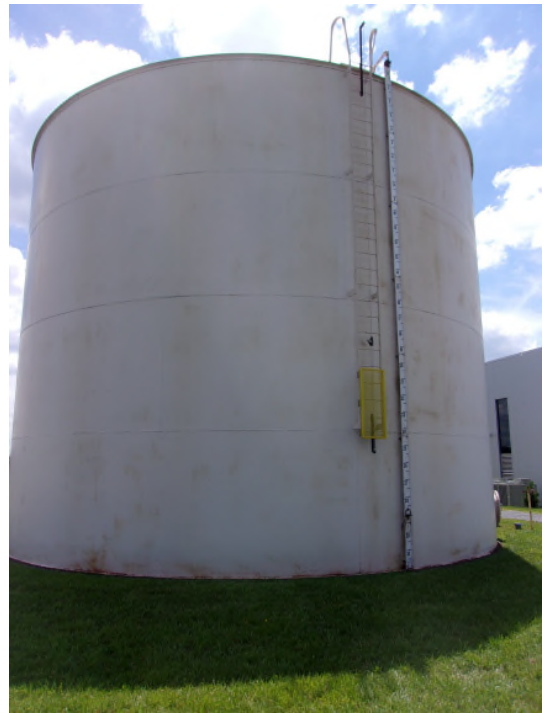
The exterior lower (6") shell and chime exhibit moderate to severe coating film failure as well a moderate rust areas. See photos in Appendix B.

**Photo #: 2**  
**Description:** Exterior Shell (4 Courses): Coating film degrading and exhibiting sporadic rust areas, Lower Shell course and circumferential chime shows the most severe corrosion areas.

The tank exterior coating system should be removed and replaced the next two (2) years. See Section 3.2 for more details'

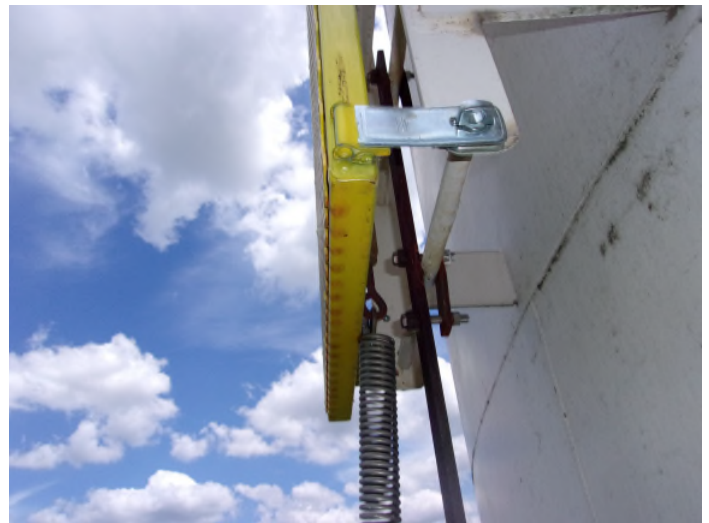
**Photo #: 4**  
**Description:** Exterior Shell: Side view of the lower five (5) feet of the Exterior Access Ladder. Note cable style safety climb framework extends below attachments to ladder rungs.

- 3.4.5 Install one, 24-inch diameter, hinged roof manway, approximately 180 degrees from the existing roof access manway.
- 3.4.6 Remove the lower eight (8) feet of the existing shell ladder as well as the wire framed cover gate and cable safety climb device.

- 3.4.7 Install a new cable safety climb device and support brackets on the modified shell ladder.
- 3.4.8 Install a new hinged solid cover gate over the lower eight (8’) feet of the modified shell ladder.

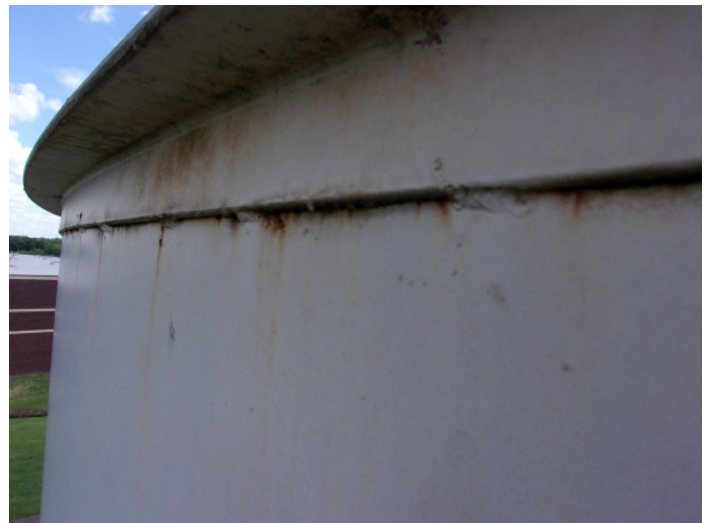
**Photo #: 8**  
**Description:** Exterior Shell/Roof Rim Angle: Spot corrosion areas along stitch welded shell/rim angle joint and general pinpoint rusting on the underside of rim angle.

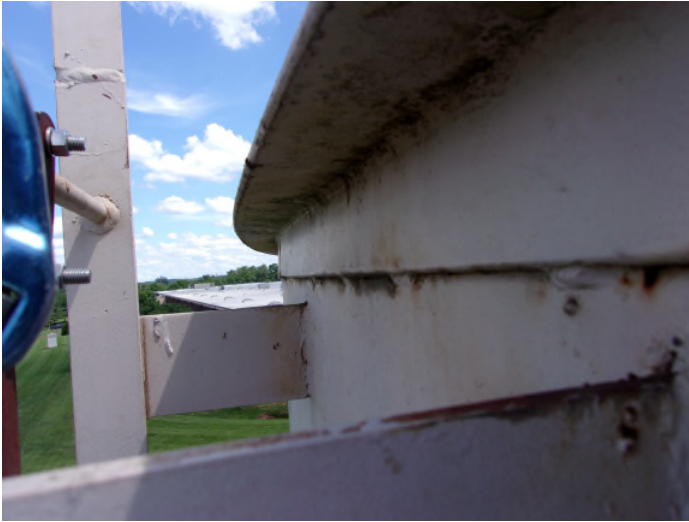
**Photo #: 9**

**Description:** Exterior Shell/Roof Rim Angle: Spot corrosion areas along stitch welded shell/rim angle joint and general pinpoint rusting on the underside of rim angle.

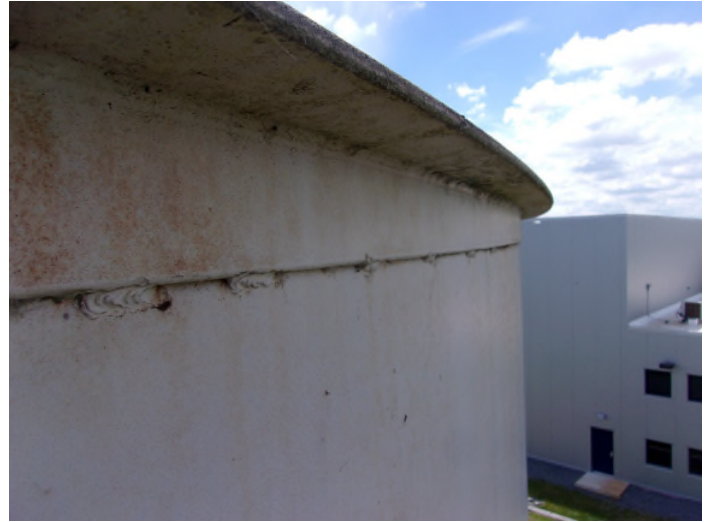
**Photo #: 10**

**Description:** Exterior Shell/Roof Rim Angle: Spot corrosion areas along stitch welded shell/rim angle joint and general pinpoint rusting on the underside of rim angle.

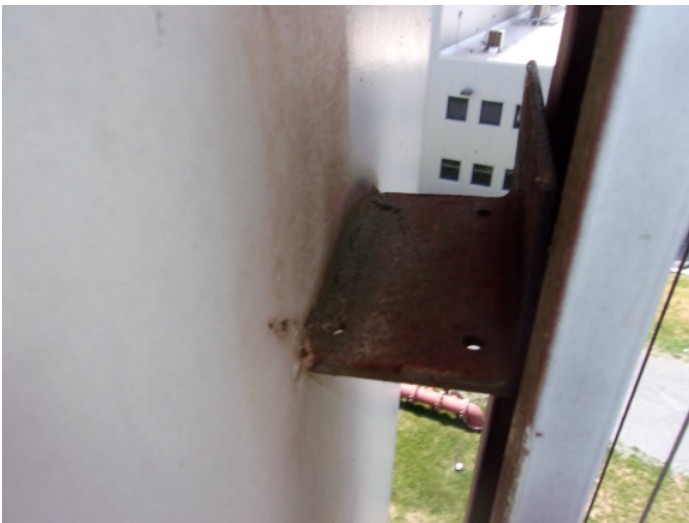
**Photo #: 11**

**Description:** Exterior Shell: Support Brackets for the interior water level indicator exhibit general corrosion with very little coating film left.

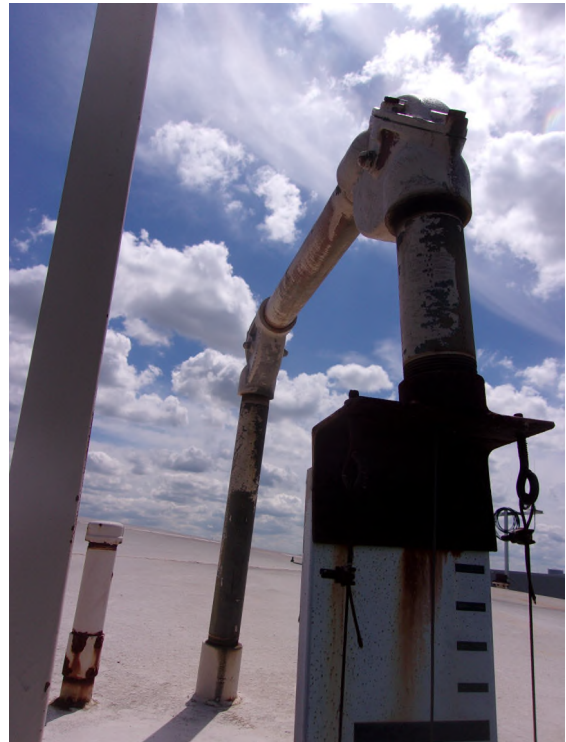
**Photo #: 12**

**Description:** Exterior Roof: Support Brackets for the interior water level indicator exhibit general corrosion with very little coating film left.

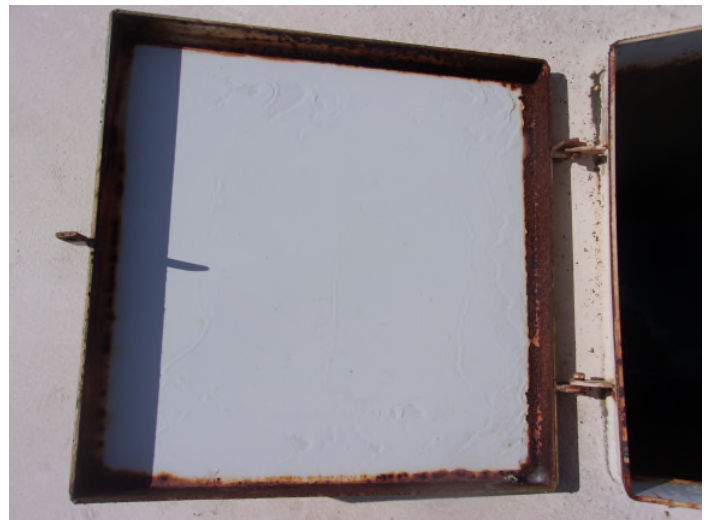
**Photo #: 16**  
**Description:** Exterior Roof: Corrosion areas on the interior cover lid for the Roof Access Manway.

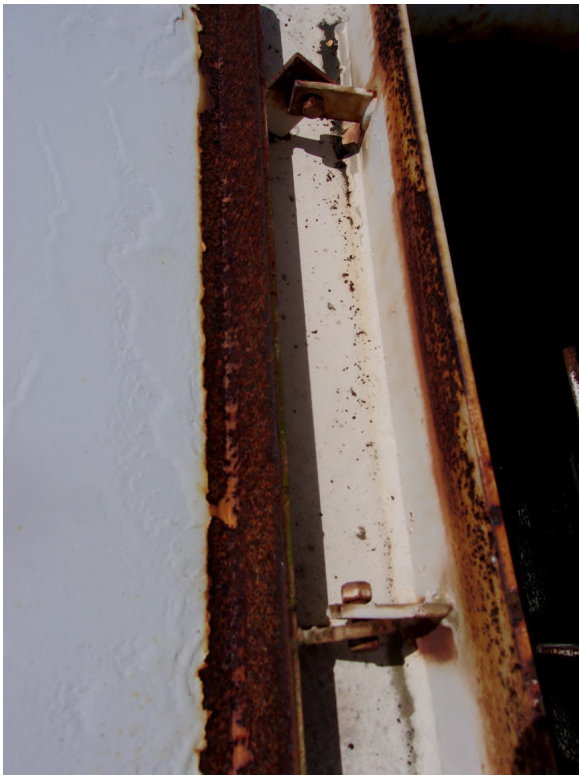
**Photo #: 17**  
**Description:** Exterior Roof: Corrosion areas on the interior cover lid and adjoining curb for the Roof Access Manway.

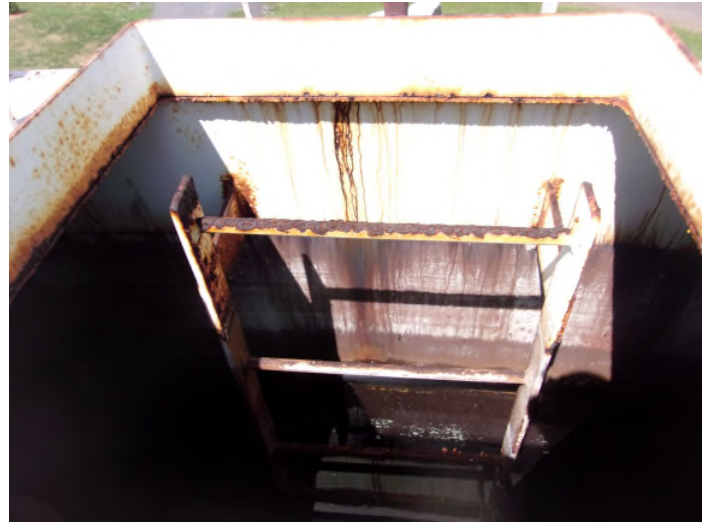
**Photo #: 18**  
**Description:** Interior Wet: Corrosion areas on the interior curb for the Roof Access Manway. Curb/roof plate interior joint is not welded. Moderate corrosion and coating film failure on the interior wet ladder (rungs, siderails, standoffs, & shell plate).

3.3.4 Seal weld, using 1/4" weld, the inside joints between the roof plate and the roof access manway's curb.

- 3.3.6 Install a solid rail safety climb device on the interior wet ladder for compliance with OSHA climbing regulations.
- 3.3.7 Severely corroded bottom flanges along the roof rafters shall be abrasive blast cleaned and evaluated for structural integrity by a registered Professional Engineer. Deficient structural items should be modified or replaced as directed by the engineering findings.

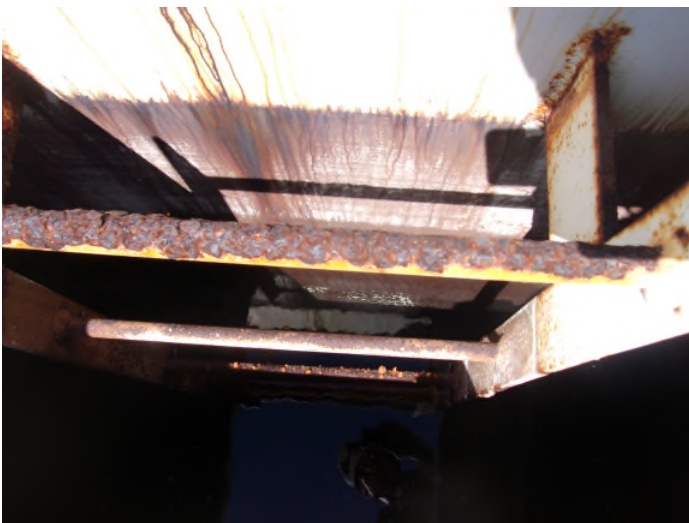
**Photo #: 19**  
**Description:** Close-up of corrosion areas on the ladder rungs.

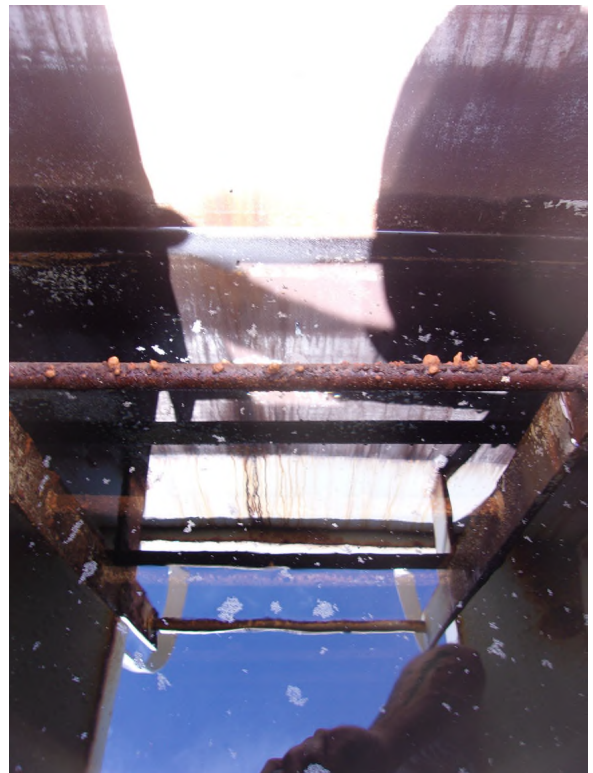
**Photo #: 20**  
**Description:** Interior Wet: Close-up view of moderate to severe corrosion on the ladder rungs.

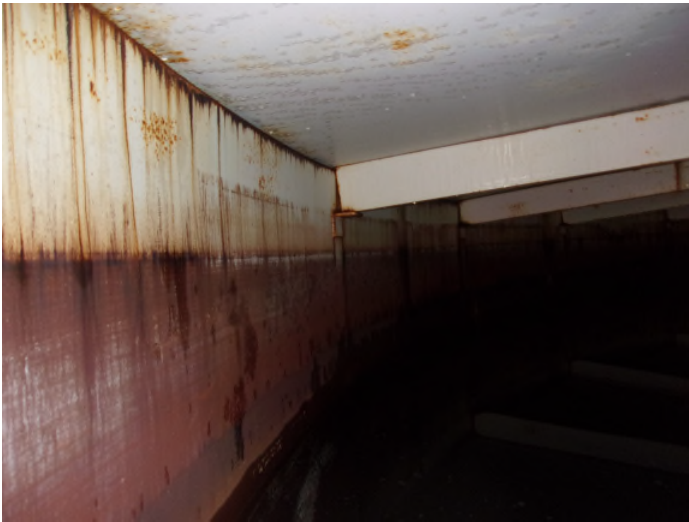
**Photo #:** 21

**Description:** Interior Wet: Moderate corrosion observed along the circumferential gap of the roof/shell rim angle joint. Spot rust areas observed on roof plates, roof rafters, and upper shell course.

3.3.1 Epoxy caulk the circumferential gap at the roof/shell plates' rim angle joints with an NSF Standard 61 approved epoxy caulking for potable water service.

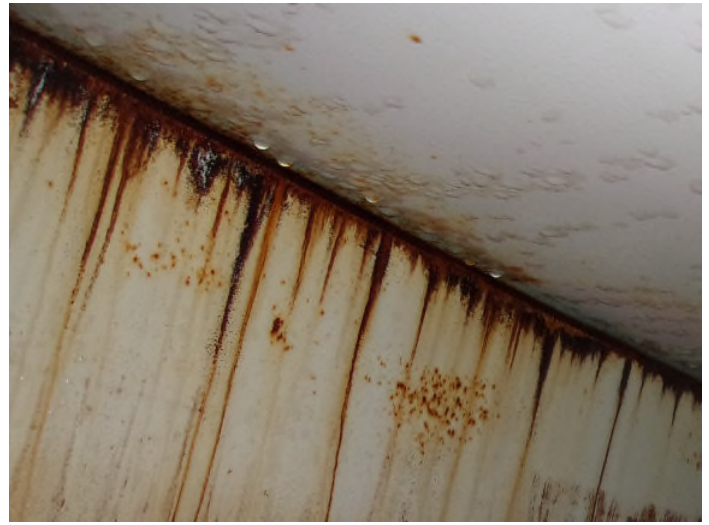
**Photo #:** 22

**Description:** Interior Wet: Close-Up view of corrosion observed along the circumferential gap of the roof/shell rim angle joint.

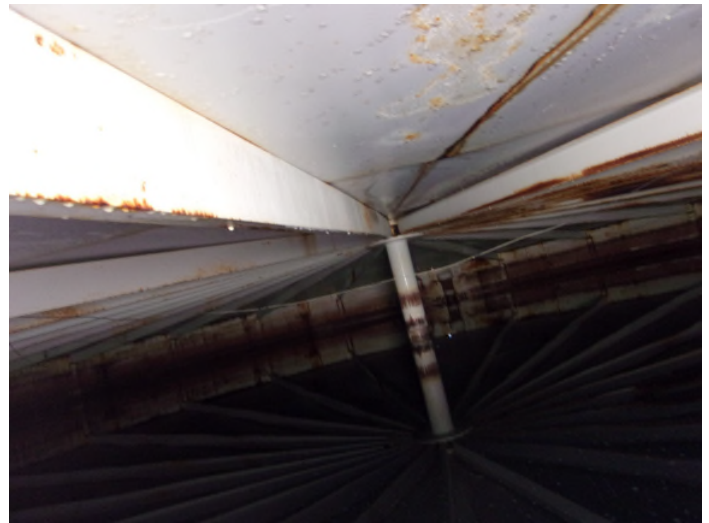
**Photo #:** 24

**Description:** Interior Wet: General view of the interior wet's roof, roof rafters, and center support column. General rust conditions observed on roof rafters. Roof plates' lap joints appear to be exterior welded.

3.3.2 Epoxy caulk the roof plate lap joints with an NSF Standard 61 approved epoxy caulking for potable water service.

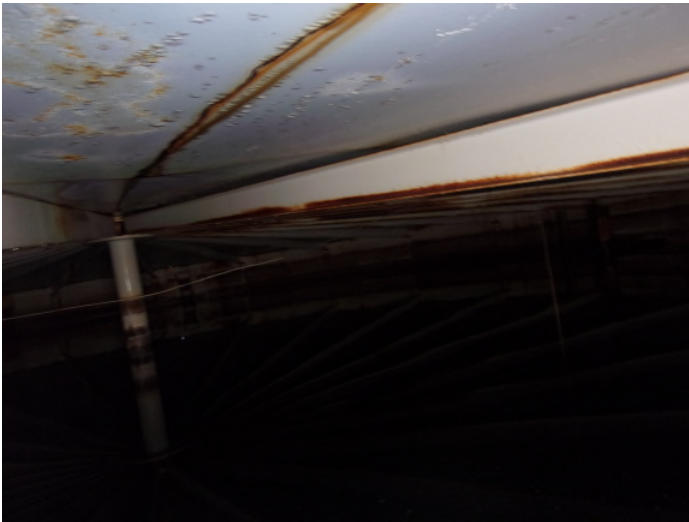
**Photo #: 25**

**Description:** Interior Wet: General view of the interior wet's roof, roof rafters, and center support column. General rust conditions observed on roof rafters. Roof rafters do not appear to be stitch welded to the roof plates.

3.3.3 Install backer rod into gap areas (>1/4") between radial rafters and roof plates and seal both sides with NSF Standard 61 approved epoxy caulking for potable water service.

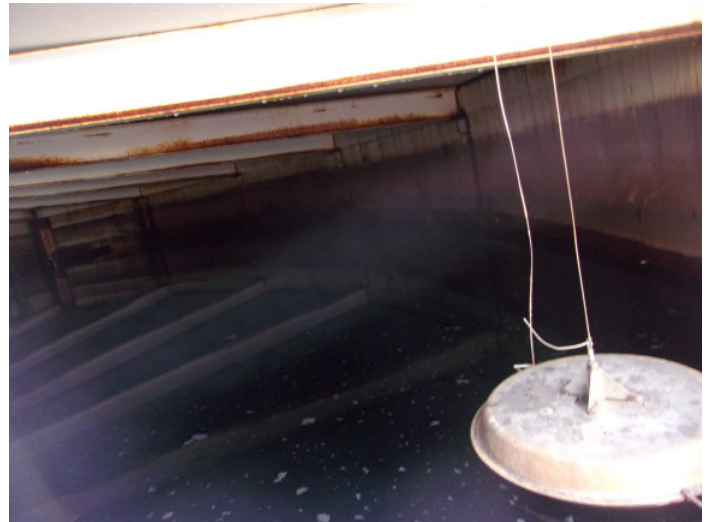
**Photo #: 26**

**Description:** Interior Wet: General view of the interior wet's roof, roof rafters, upper shell course, and flotation device for exterior water level indicator. General rust conditions observed on roof rafters.

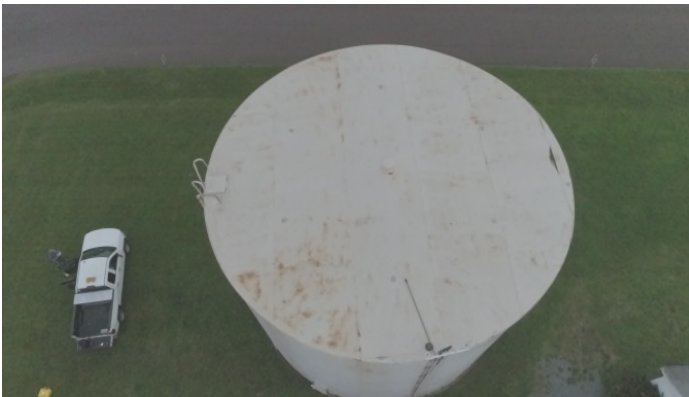
**Photo #: 27**

The exterior coating system's film on the roof and shell has been degraded and exhibits moderate to severe chalking which is allowing widespread pinpoint rust areas to be exposed through the coat system's film.

**Description:** Exterior Roof (Aerial Drone Photograph): Roof coating film exhibits general degradation due to ultraviolet light.

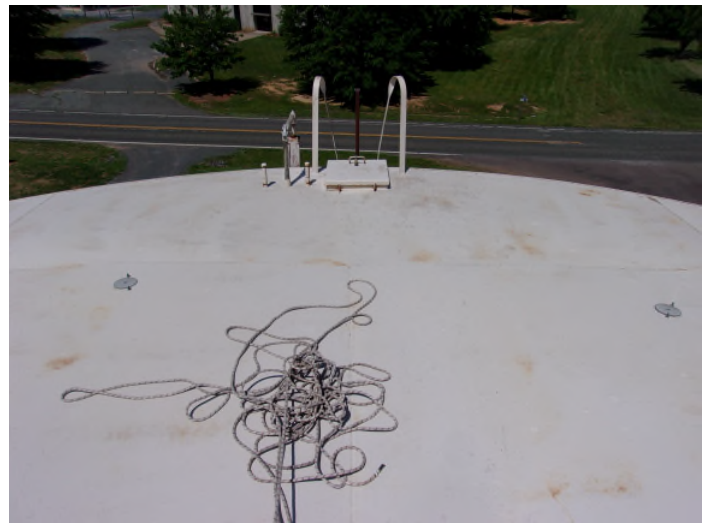
**Photo #: 28**

**Description:** Exterior Roof: Roof coating film exhibits general degradation due to ultraviolet light. Sporadic pinpoint rust areas are evident.

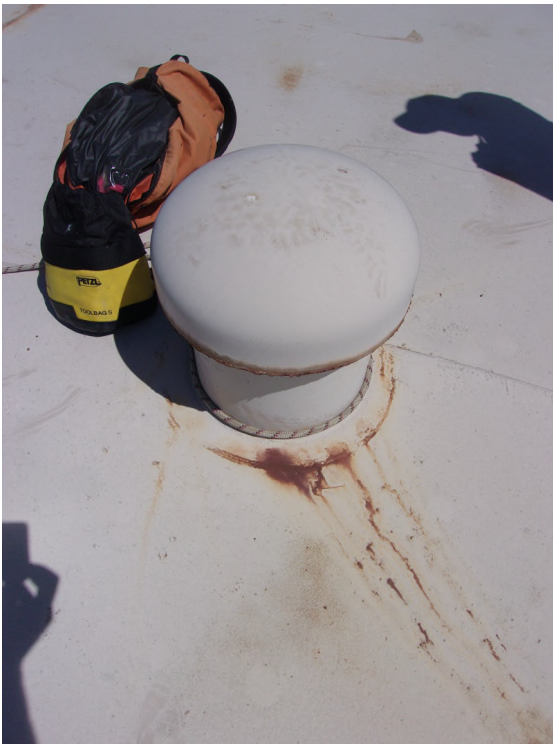
**Photo #: 29**  
**Description:** Exterior Roof: Center Roof Vent. Unknown device appears to have formed a circular corrosion area on the roof plate around the neck of the roof vent.

- 3.4.1 Remove the existing fixed roof vent. Install a new vent with a removable mushroom style vent cover with a vacuum freeze component and a new flange base with a 24” interior diameter. Use a corrosion resistant, heavy-gauge, No.24 SS mesh screen.

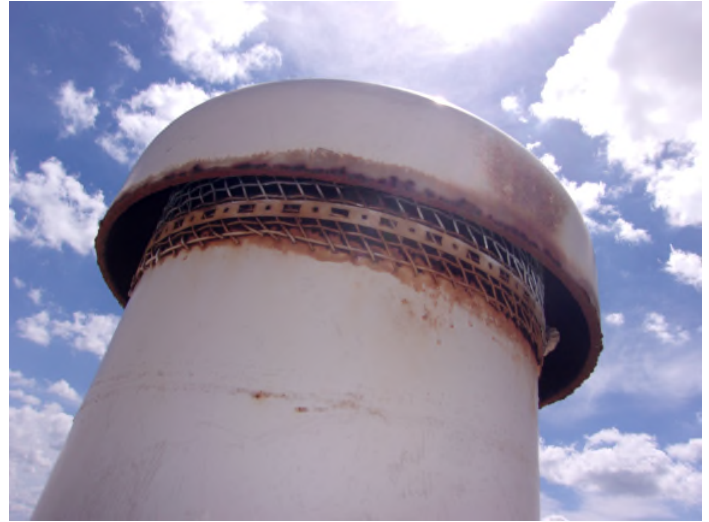
There are also corrosion areas on the underside of the center roof vent's mushroom cover and neck.

**Photo #: 30**  
**Description:** Exterior Roof: Center Roof Vent. Number 4 SS mesh screen and held in-place by tension strap. Underside of the roof cover plate exhibits general corrosion.

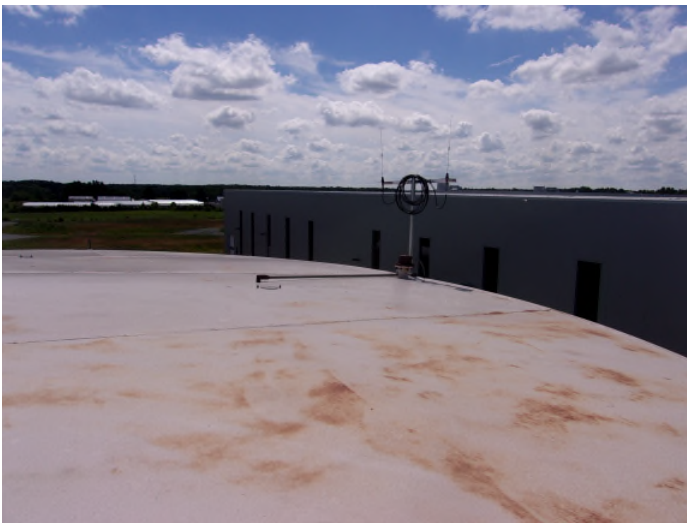
**Photo #: 31**  
**Description:** Exterior Roof: Roof coating film exhibits general degradation due to ultraviolet light. Rust areas are showing up all over the roof.

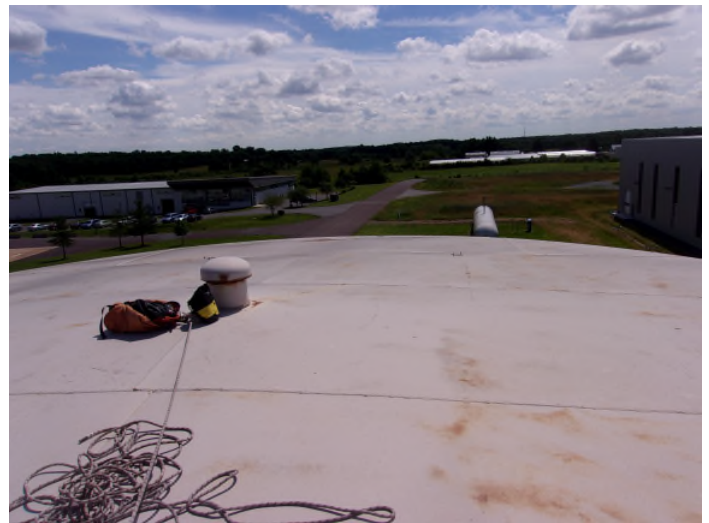
**Photo #: 32**  
**Description:** Exterior Roof: Roof coating film exhibits general degradation due to ultraviolet light. Rust areas are showing up all over the roof.

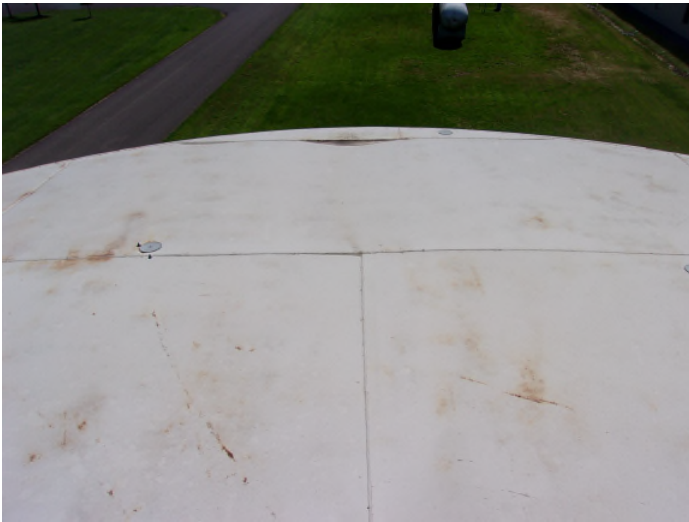
**Photo #: 33**

**Description:** Exterior Roof (180 Degrees): Roof coating film exhibits general degradation due to ultraviolet light. Rust areas are showing up all over the roof. Ponding area observed close to the edge of the exterior roof.

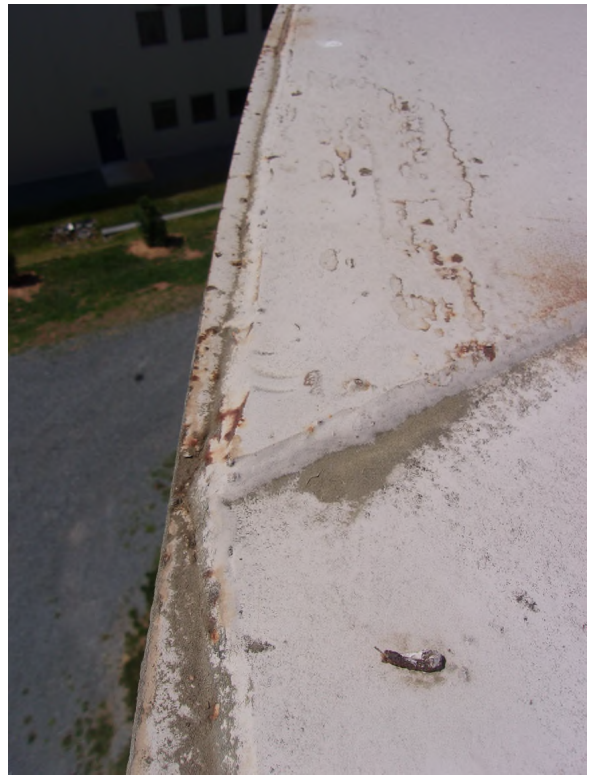
**Photo #: 34**

**Description:** Exterior Roof: Corrosion areas along the roof's circumference.

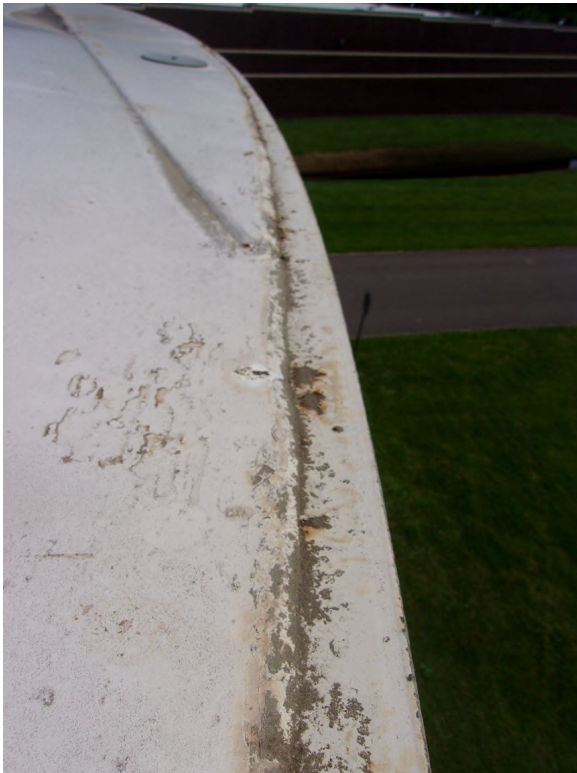
**Photo #: 35**

**Description:** Exterior Roof: Corrosion areas along the roof's circumference.

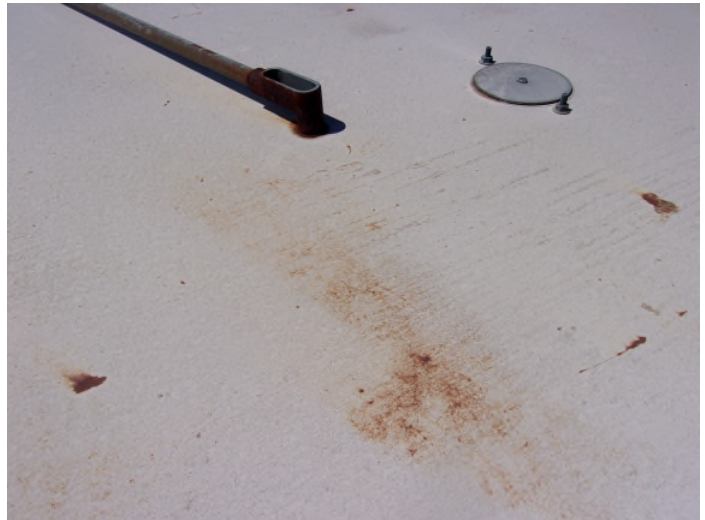
**Photo #: 36**

**Description:** Exterior Roof: General View of cathodic protection access hole with intact cover plate. Conduit pipe/roof plate penetration does not have an installed cover plate and is allowing unauthorized water access to the interior wet water supply.

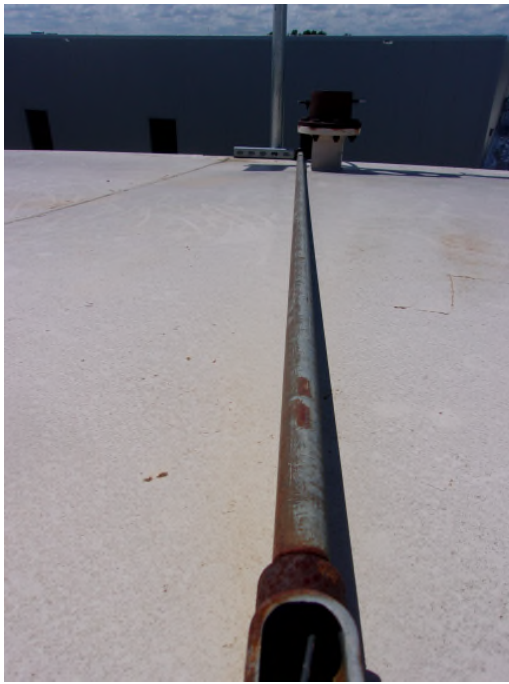
**Photo #: 37**

**Description:** Exterior Roof: General View of cathodic protection wiring conduit. Conduit pipe/roof plate penetration does not have an installed cover plate and is allowing unauthorized water access to the interior wet water supply.

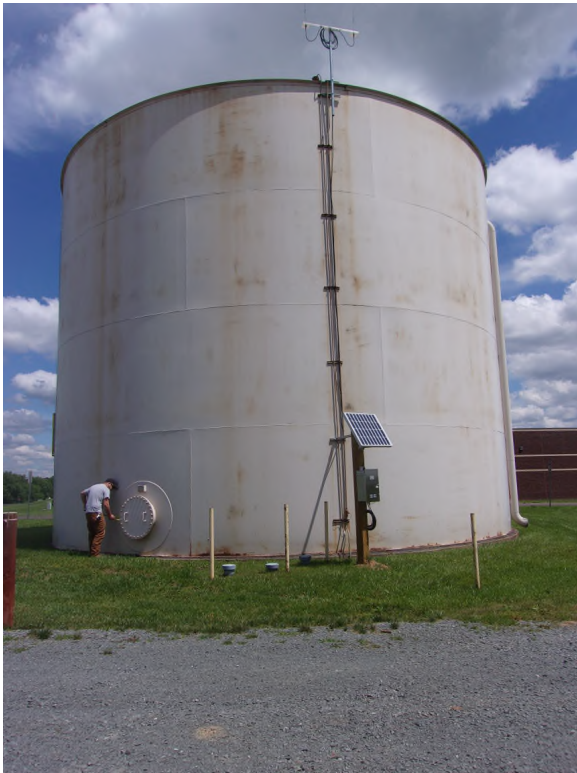
**Photo #: 39**

**Description:** Exterior Shell: General corrosion areas visible on all 4 shell courses.

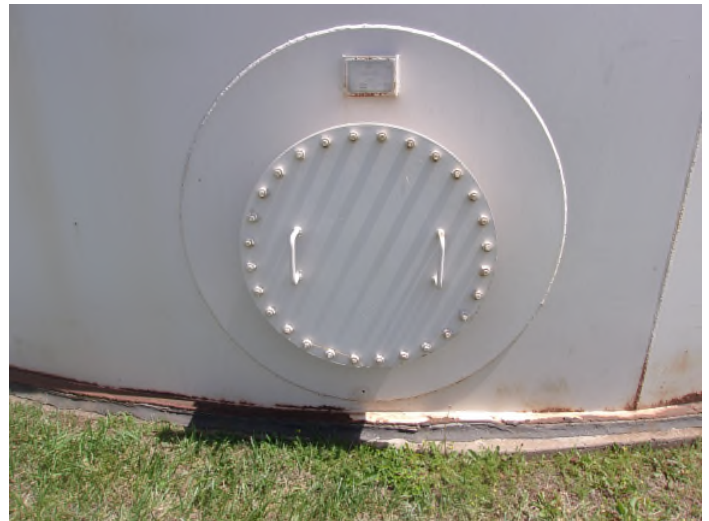
**Photo #: 40**

**Description:** Exterior Shell: 1st Shell Manway (24" inside diameter) with tank ID plate. Fabricator - Industrial Alloy Fabricators. No davit in-place. Chime area shows moderate corrosion and coating film failure.

- 3.4.9 Install a davit on each of the two (2) shell manways.
- 3.4.10 Remove the existing screen assembly over the overflow pipe outlet and install a flanged plate to the outlet opening to allow bolted connections.

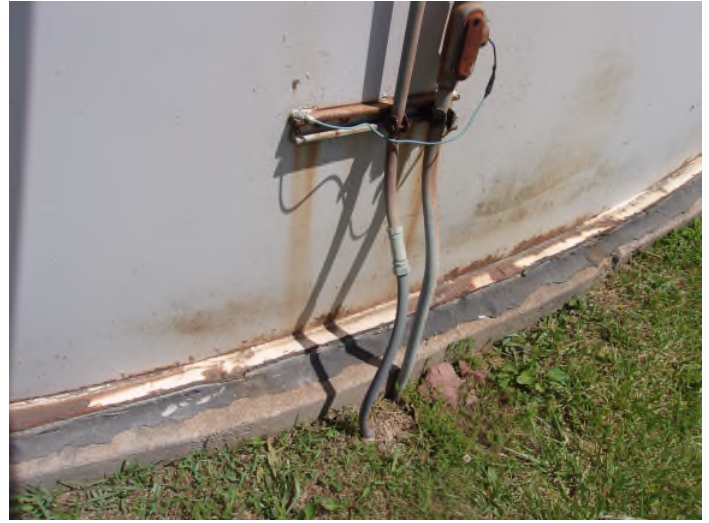
**Photo #: 42**  
**Description:** Exterior Shell: Wiring conduit and uni-strut support bracket. Chime/shell area exhibits coating failure.

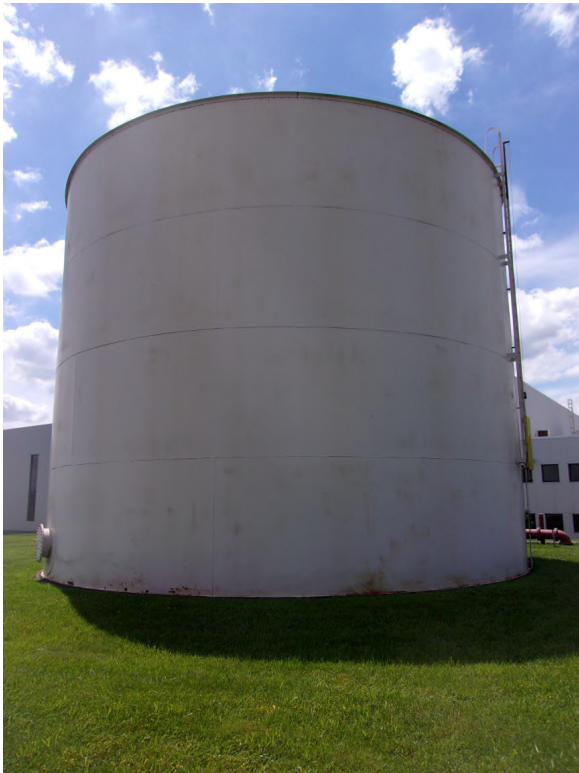
**Photo #: 43**  
**Description:** Exterior Shell: General corrosion areas visible on all four (4) shell courses.

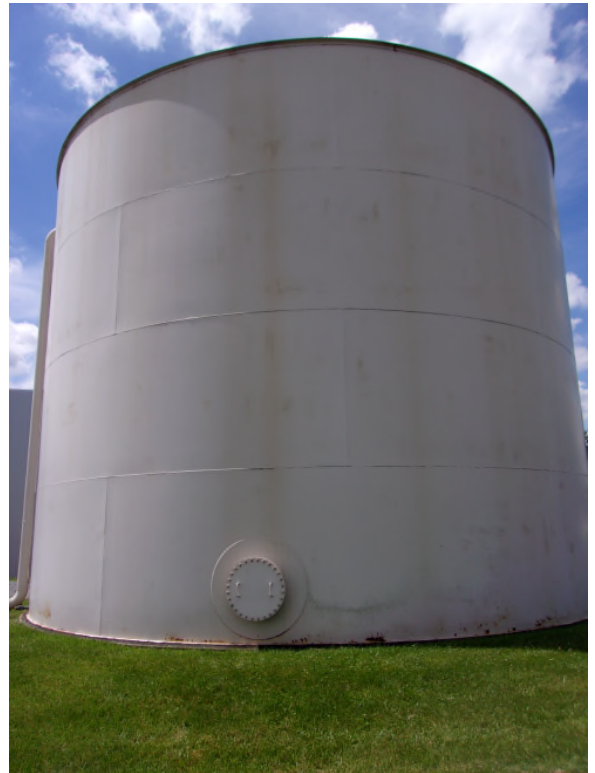
**Photo #: 44**  
**Description:** Exterior Shell: General corrosion areas visible on all four (4) shell courses.

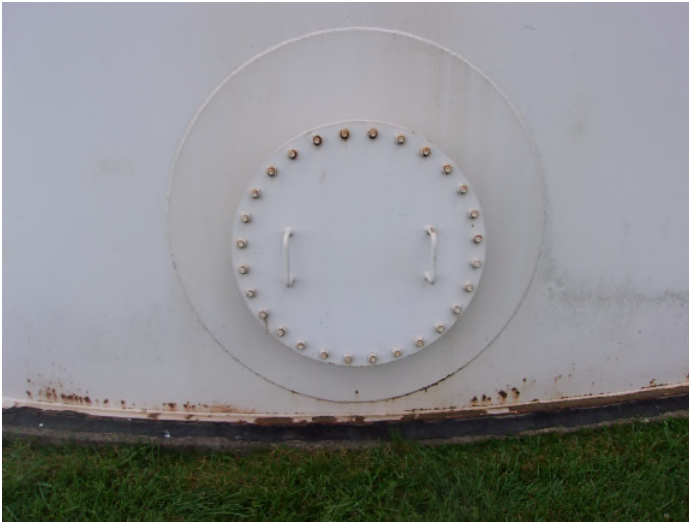
**Photo #: 45**

**Description:** Exterior Shell: 2d Shell Manway (24" inside diameter) with no davit in-place. Chime and lower shell areas show moderate corrosion and coating film failure. Circumferential chime/concrete ring wall joint coated with tar.

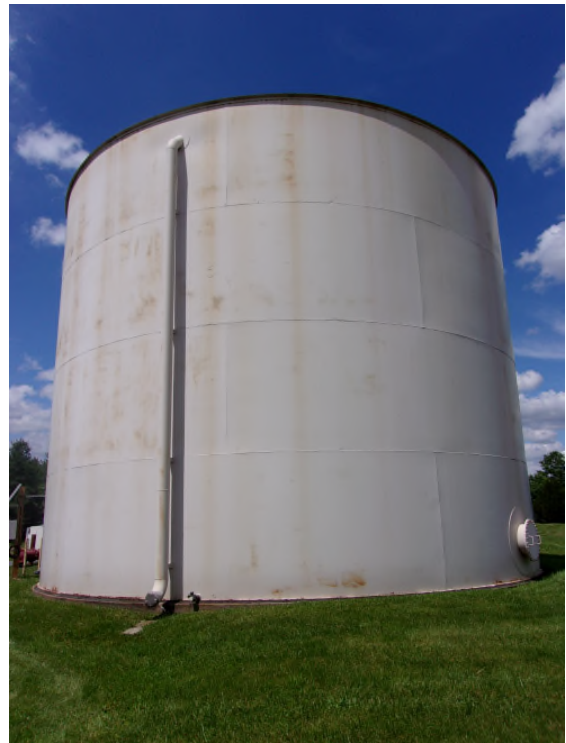
**Photo #: 46**

**Description:** Exterior Shell: General corrosion areas visible on all four (4) shell courses. Exterior overflow pipe (8" diameter) and splash pad shown.

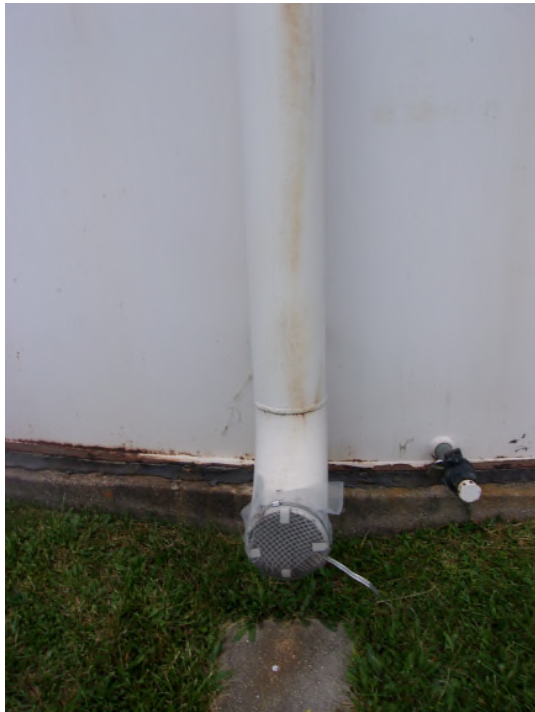
**Photo #: 47**

**Description:** Exterior Shell: Close-Up View of overflow pipe outlet and concrete splash pad. Cover screen over end of overflow pipe outlet held in-place with tension strap. Unknown pipe penetration and lower shell course just above the chime.

- 3.4.11 Install a properly sized TideFlex Flapper valve at the modified overflow pipe outlet.
- 3.4.12 Remove the existing asphalt sealant covering the chime/concrete ring-wall joint area.

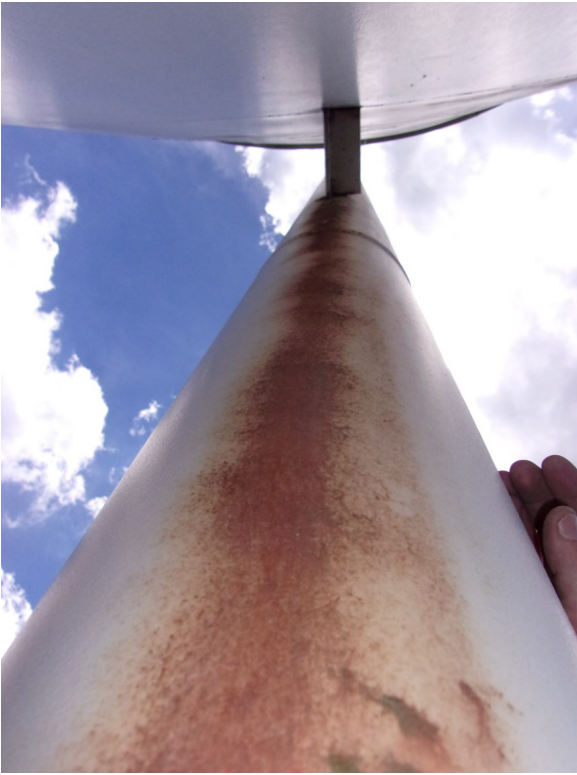
**Photo #: 49**  
**Description:** Exterior: General corrosion area along the backside of the overflow pipe.

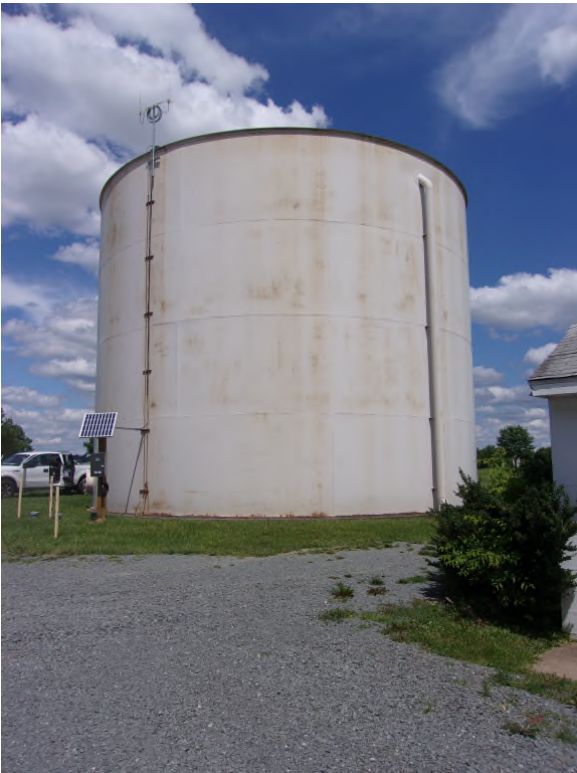
**Photo #: 51**  
**Description:** Exterior Shell: General corrosion areas visible on all four (4) shell courses.

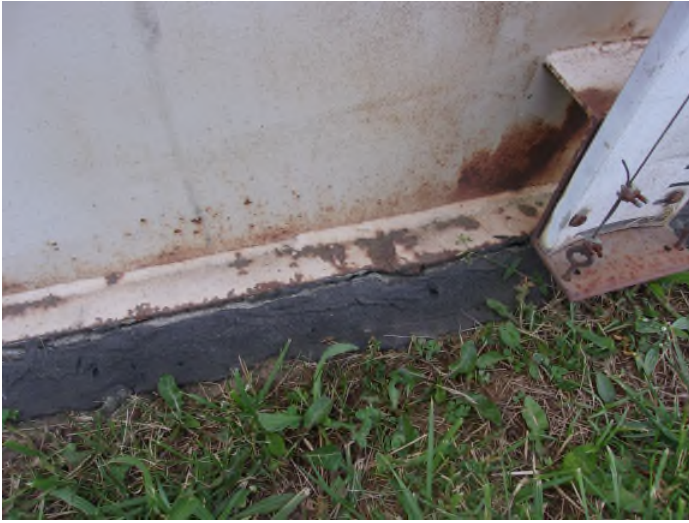
**Photo #:** 53  
**Description:** Exterior Shell/Chime: Surrounding grade almost even with top of chime area.

3.5.1 Lower and contour the surrounding landscape so that the grade is 4 to 6" below the top of the tank chime/ring-wall foundation.

3.5.2 Landscape contour operations should route ground water and overflow pipe outlet discharges to an adjacent ditch or storm drain.

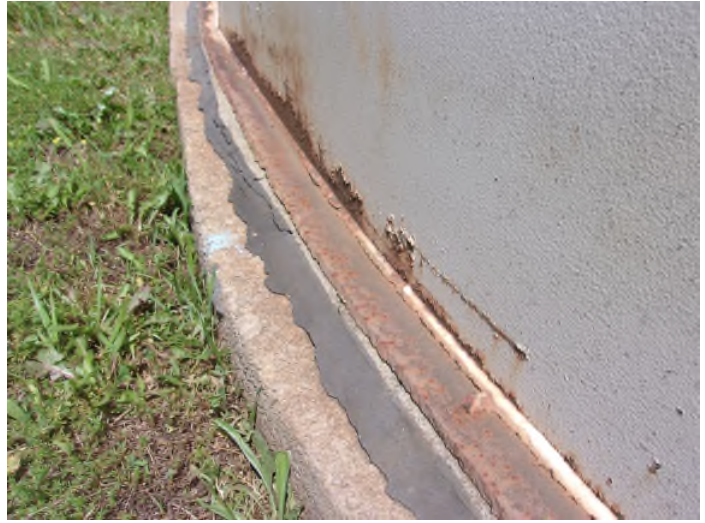
**Photo #:** 54  
**Description:** Exterior: Tar sealant application cover chime/fiberboard joint has failed.

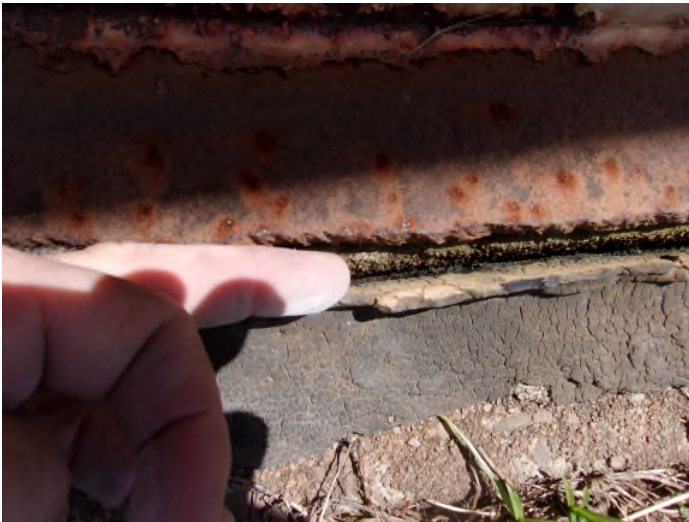
**Photo #:** 55  
**Description:** Exterior: Tar sealant application cover chime/fiberboard joint has failed.

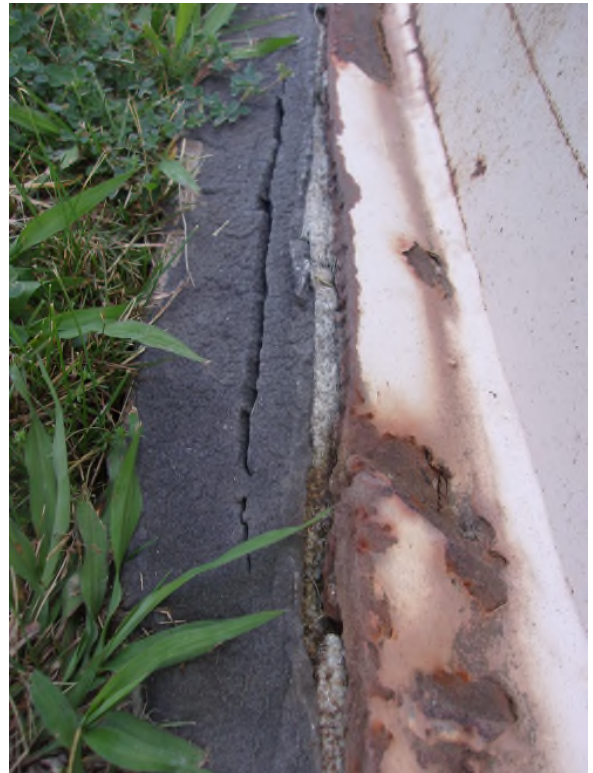
**Photo #:** 56  
**Description:** Exterior: Tar sealant application cover chime/fiberboard joint has failed. Spalling concrete observed.

- 3.4.13 Remove the loose, cracked, and spalled grout and concrete under the tank’s chime. Repair using non-shrink 3000 PSI grout.

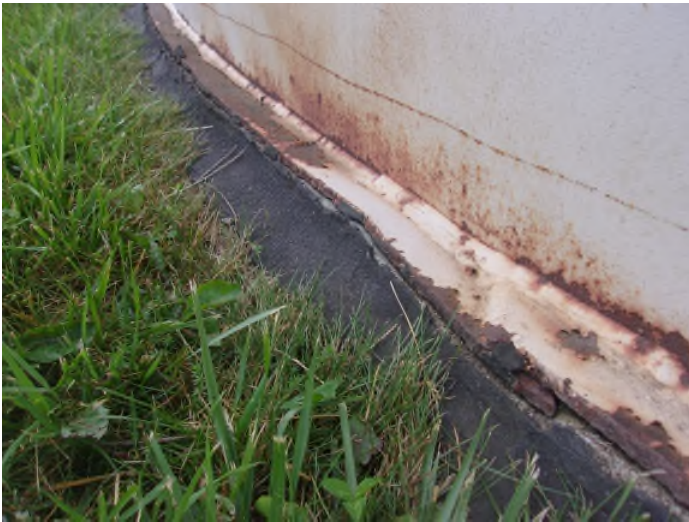
**Photo #: 57**

**Description:** Exterior Shell: Chime and lower shell areas show moderate corrosion and coating film failure. Circumferential chime/concrete ring wall joint coated with tar.

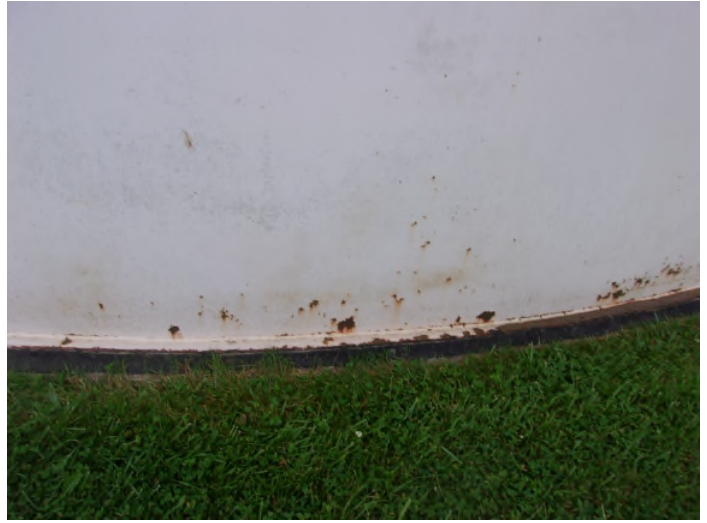
**Photo #: 58**

**Description:** Exterior: Landscape damage to coating film probable cause for some of the lower shell course rust areas.

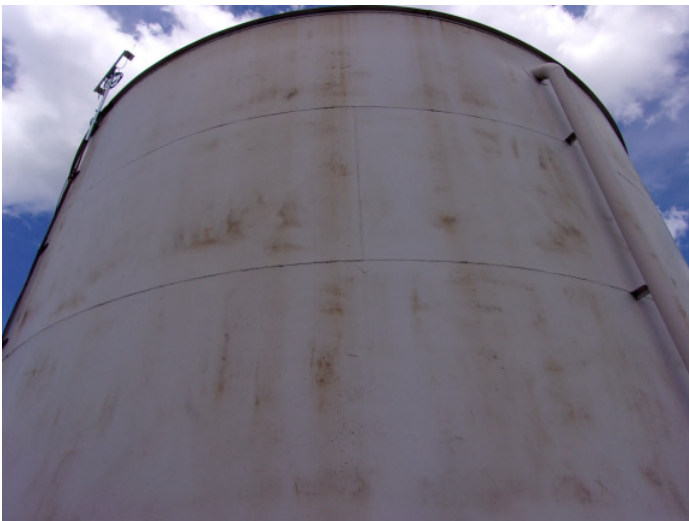
**Photo #: 59**

**Description:** Exterior Shell: Close-Up view of general corrosion areas.

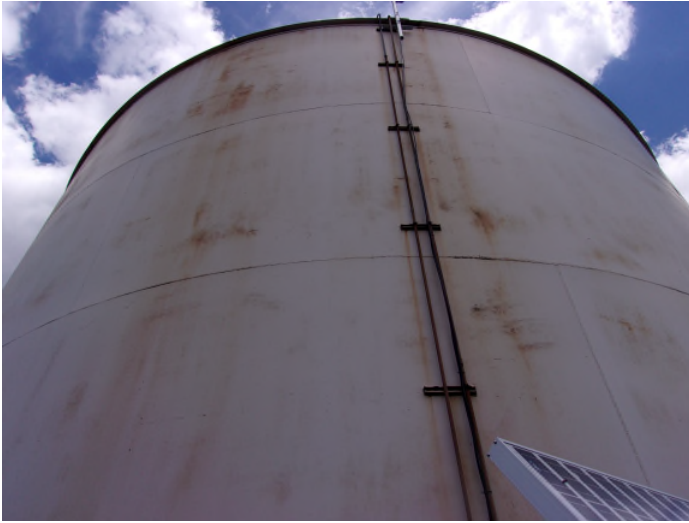
**Photo #:** 61

**Description:** Exterior Shell: Close-Up view of general corrosion areas.
