**ATTACHMENT XI**  
**PARENT / DAUGHTER COC MASS EVALUATION CHARTS 1-4**  
**(ATTACHMENT WAS ADDED BY THE USER)**

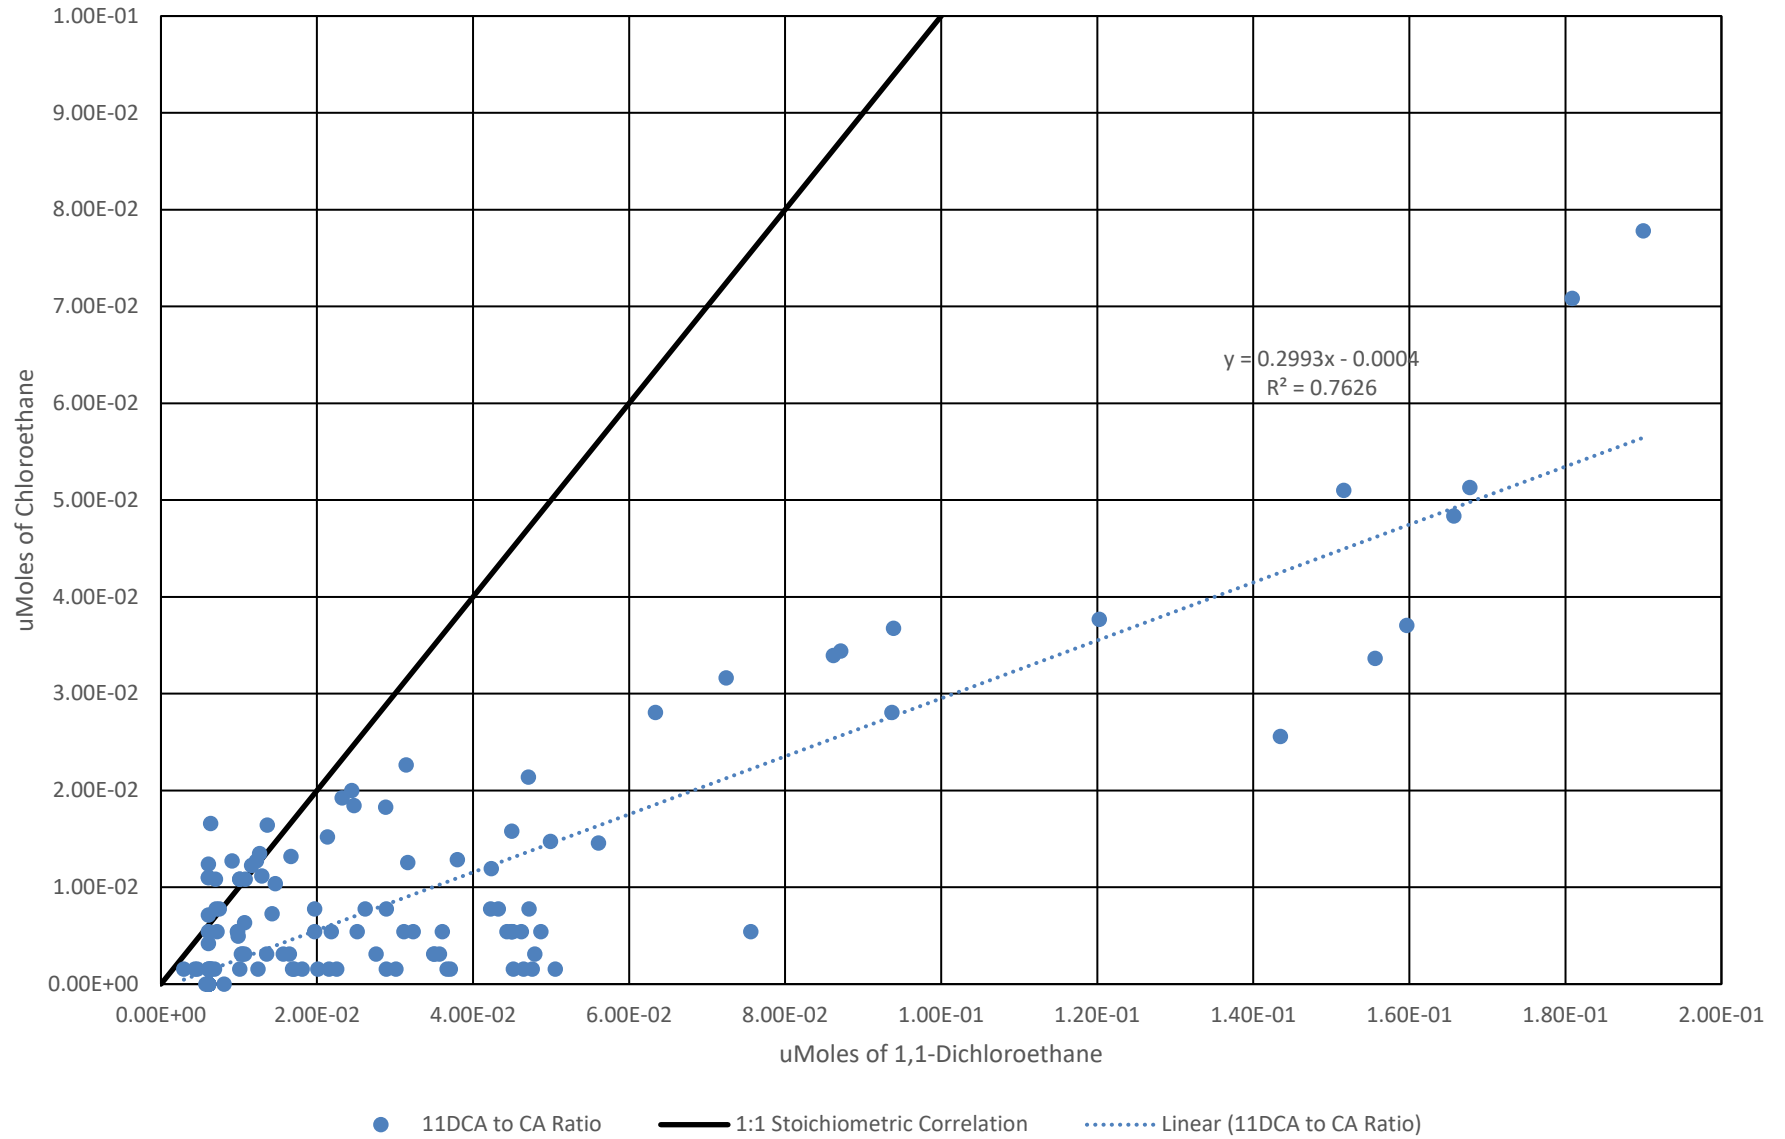
Chart 1  
 Closed Laurel Valley Center Sanitary Landfill, Permit No. 251  
 Sentinel and Performance Well 1,1-Dichloroethane to Chloroethane Ratios (2016-2020)

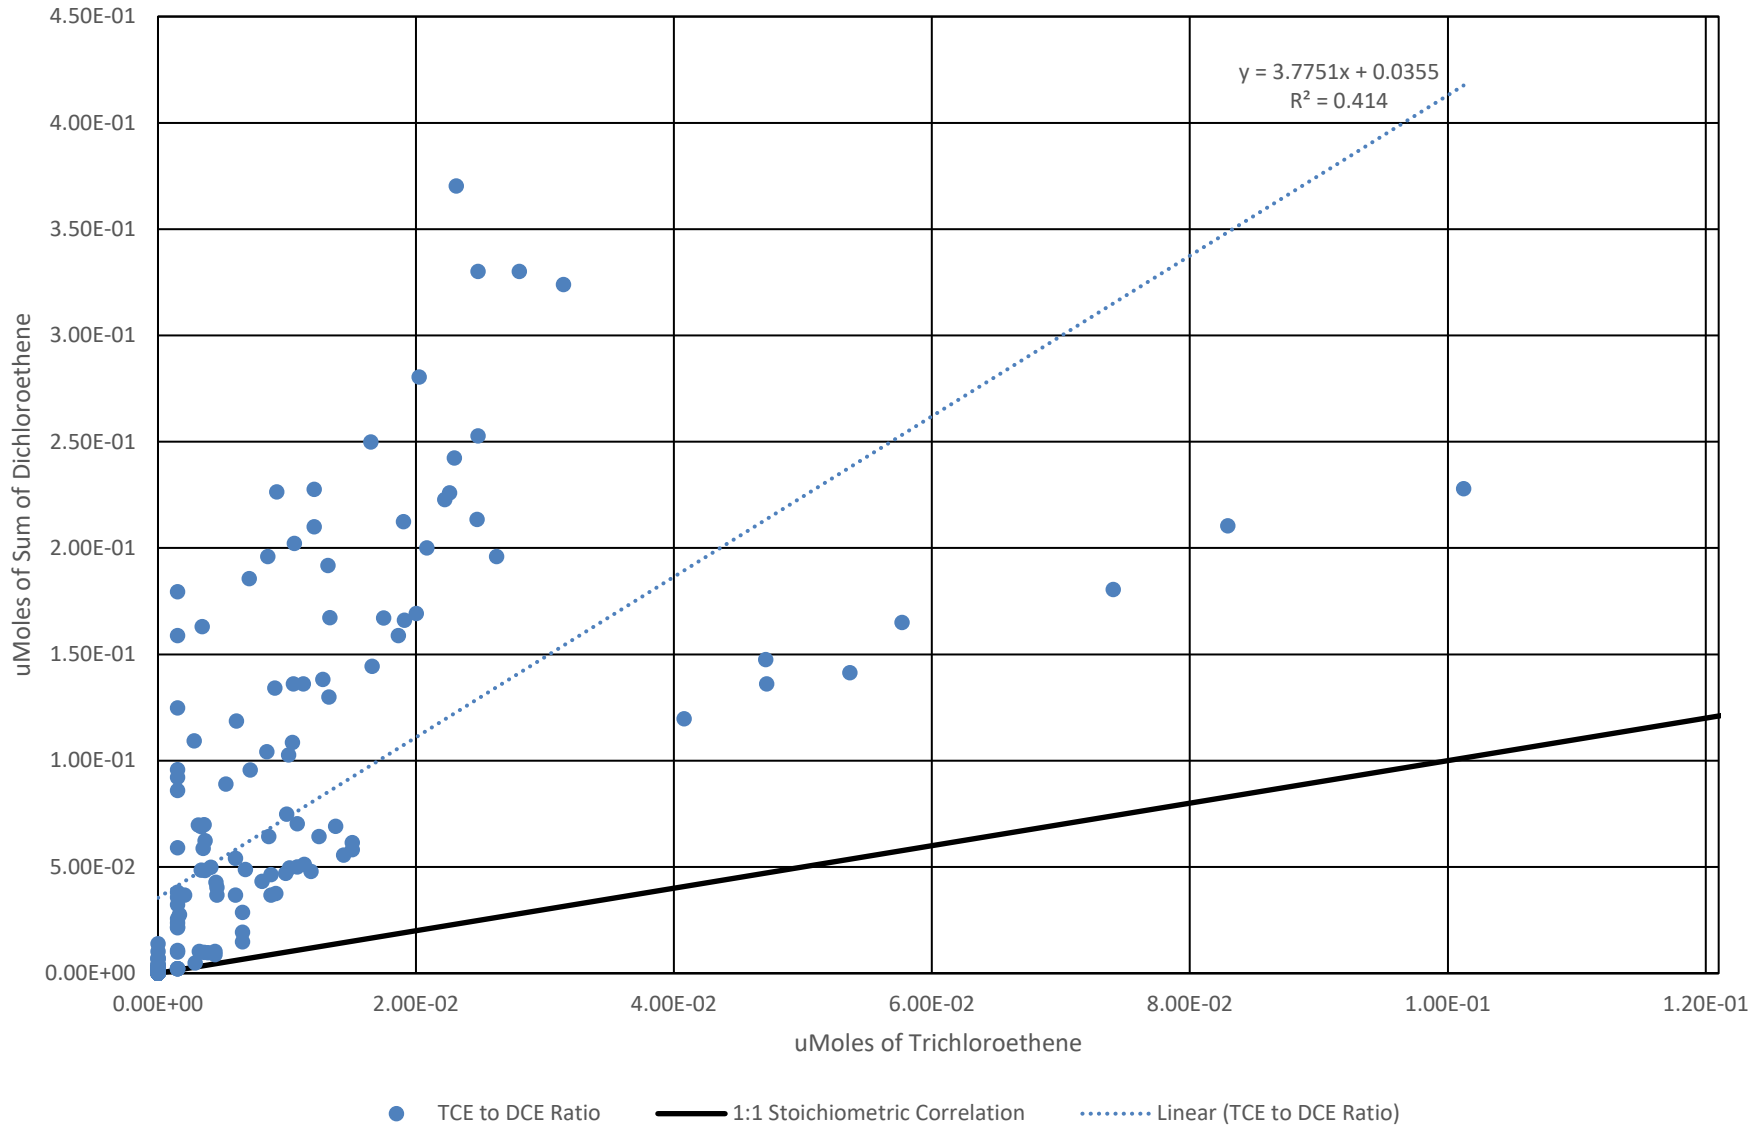
Chart 3  
 Closed Laurel Valley Center Sanitary Landfill, Permit No. 251  
 Sentinel and Performance Well Trichloroethene to Sum of Dichloroethene Ratios (2016-2020)

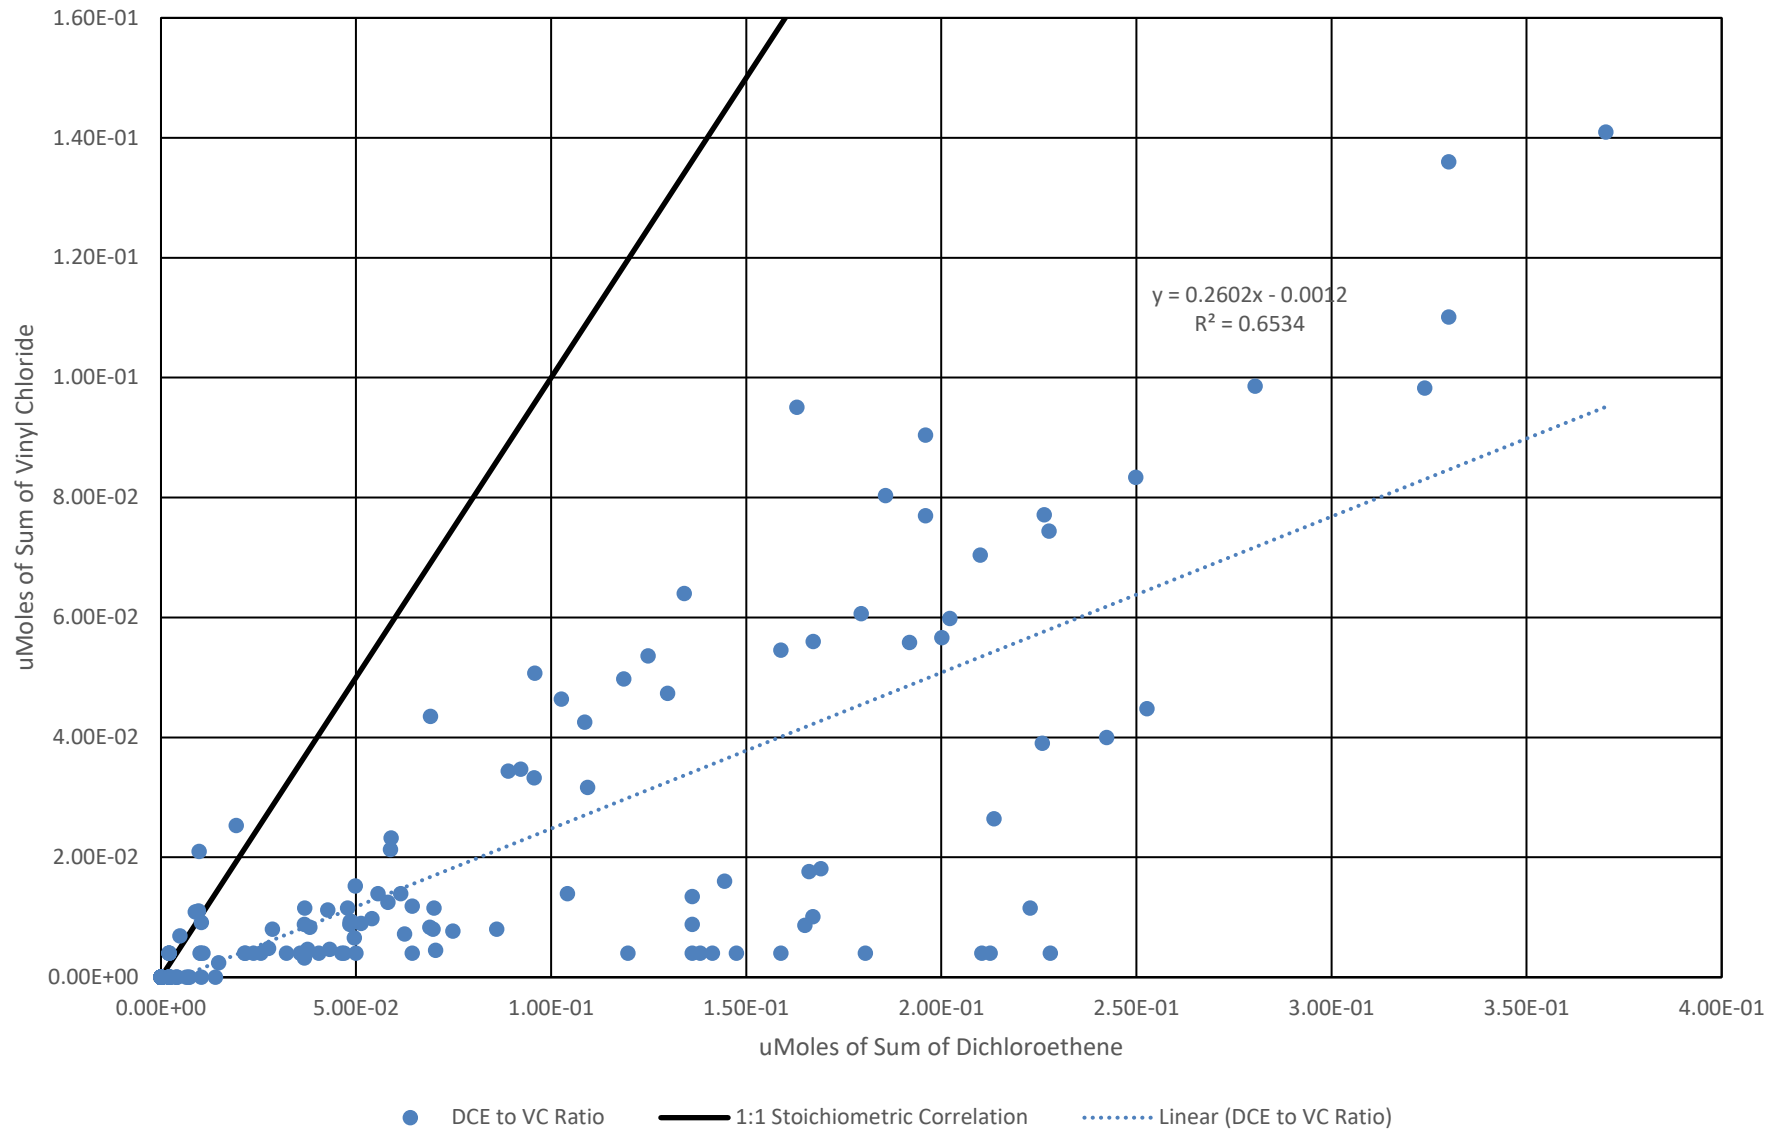
Chart 4  
 Closed Laurel Valley Center Sanitary Landfill, Permit No. 251  
 Sentinel and Performance Well Sum of Dichloroethene to Vinyl Chloride Ratios (2016-2020)
